Manhole Inspection Summary

Manhole # S39E__007MH

Inspection ☐ Is Incomplete Rating: **5) Immediate Attention Required**

Location Address: **e fayette st**

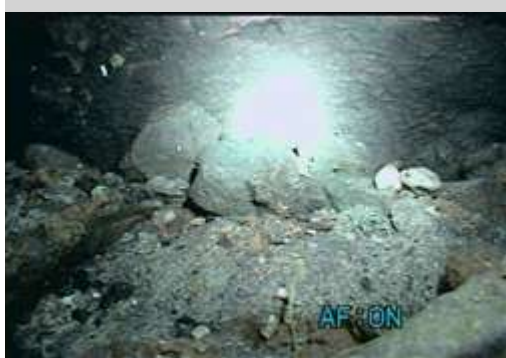
Defect 3

Condition: ☐ Sound ☐ Cracked ☐ Root Intrusion ☐ Deteriorated ☐ Leaks ☒ **Debris**

channel debris

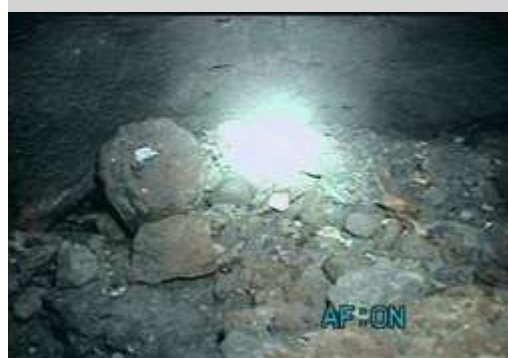
Defect 2

Condition: ☐ Sound ☐ Cracked ☐ Root Intrusion ☐ Deteriorated ☐ Leaks ☒ **Debris**

bench debris

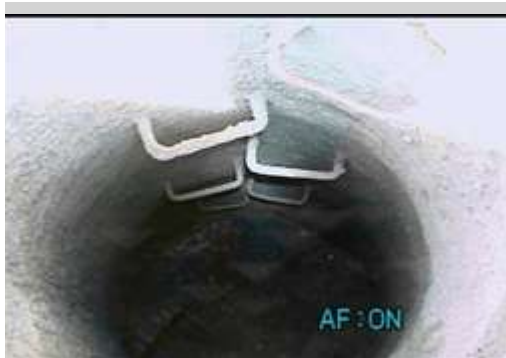
Defect 1

Count: **6** Missing: **0** ☒ **Corroded**

steps

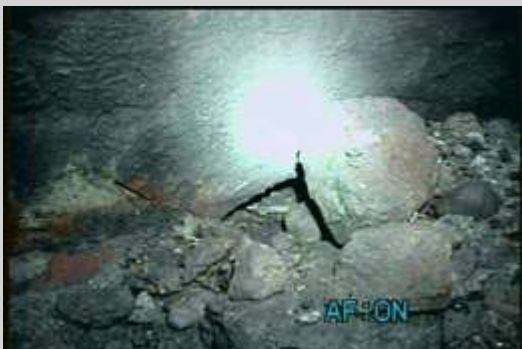
6 O'Clock Inflow

8 in. Circular Gravity Sewer
Pipe In @ 6 O'Clock

Deposits: ☐ None ☐ Mud ☐ Sludge ☒ **Debris** ☐ Grease

Silt Depth: 7 (in.) Deposits Extent: **Heavy**

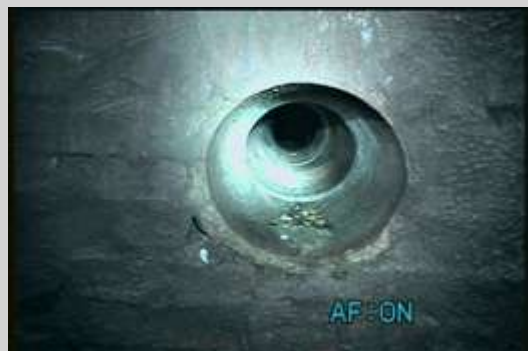
9 O'Clock Inflow

Comments **aaa The drop at 9 and most of six are covered.**

8 in. Circular Gravity Sewer
Pipe In @ 9 O'Clock
